# HOME REPORT

FLAT 1/1  
254 BATH STREET  
GLASGOW  
G2 4JW

# ENERGY PERFORMANCE CERTIFICATE

# Single Survey

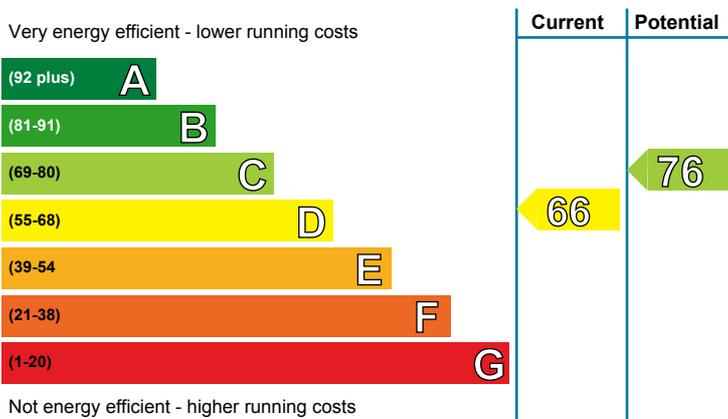
## Energy Efficiency Rating

This graph shows the current efficiency of your home, taking into account both energy efficiency and fuel costs. The higher this rating, the lower your fuel bills are likely to be.

Your current rating is **band D (66)**. The average rating for EPCs in Scotland is **band D (61)**.

The potential rating shows the effect of undertaking all of the improvement measures listed within your recommendations report.

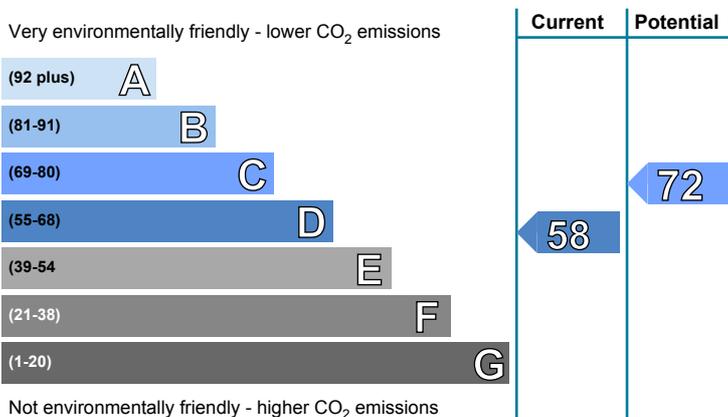
## Environmental Impact (CO<sub>2</sub>) Rating

This graph shows the effect of your home on the environment in terms of carbon dioxide (CO<sub>2</sub>) emissions. The higher the rating, the less impact it has on the environment.

Your current rating is **band D (58)**. The average rating for EPCs in Scotland is **band D (59)**.

The potential rating shows the effect of undertaking all of the improvement measures listed within your recommendations report.
